WRIA 22 Fish Passage Inventory

Mason Conservation District

127Y0433

Stream: Wilson Creek
Tributary To: Chehalis 22.0190
WRIA: 22.0236
Fish Use: Yes
FUP Criteria: Biological

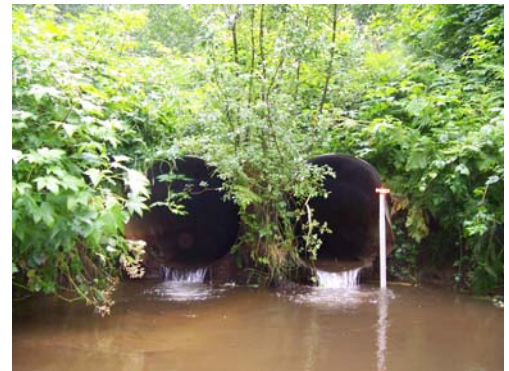
Pipe 1.2 is on left bank. Culvert is sloped inversely and rusted out at outlet. Mouth of culvert plugged with sediment and debris, only half of mouth is visible. Majority of water passes through pipe 1.2.

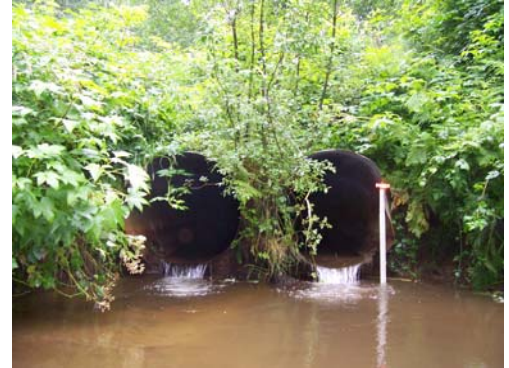
Pipe 2.2 is on right bank. Culvert is sloped inversely and rusted out at outlet. Mouth of culvert is submerged and almost completely clogged with sediment and debris.
